## **2013 Colorado Flooding - CRS Success Stories**

Compiled By: Marsha Hilmes-Robinson, CASFM CRS Committee Chair

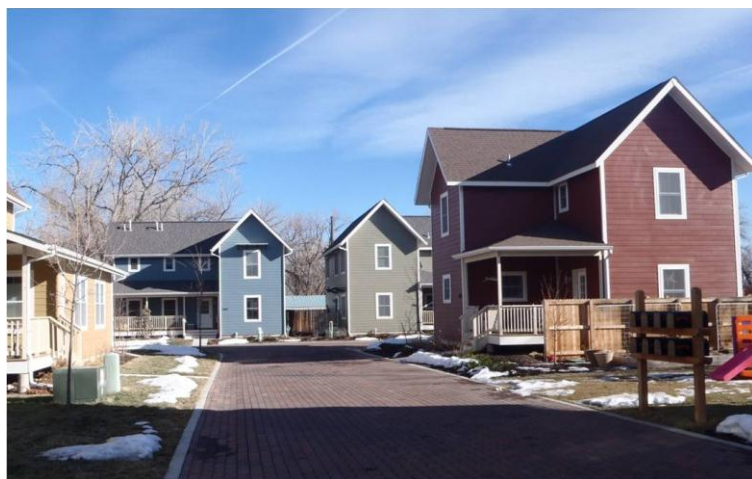
**Photo 1.** Toby Lane Development in Boulder protected from flood damage in September 2013 because the homes were elevated two feet above the 100-year flood elevation.

The Toby Lane Development was within the newly re-mapped floodplain of South Boulder Creek. The City of Boulder started regulating development in the remapped floodplain prior to approval by FEMA. Houses were required to meet the City's higher freeboard standard of 2 feet above 100-year flood elevation. Because the homes were elevated, they were not damaged in the flood.

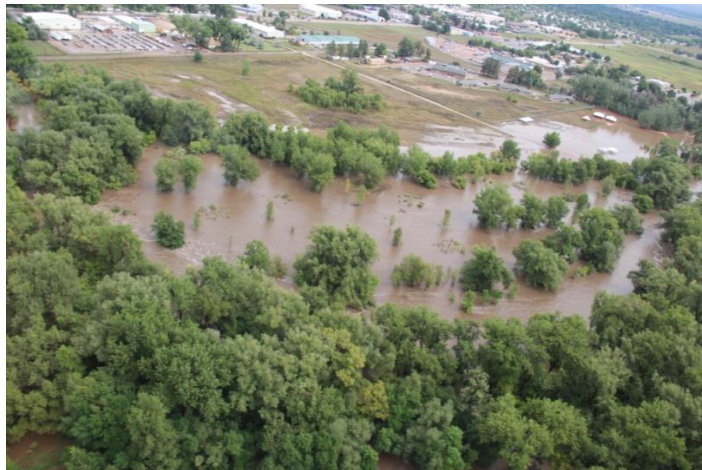
**Photo 2.** Open Space preserved in McMurry Natural Area and Legacy Park along the Poudre River in Fort Collins. Floodwaters in September 2013 were able to spread out and slow down and not cause any damages.

The flooding on the Poudre River was a 50-year event with a flow of approximately 10,400 cfs at the Mouth of the Canyon. There was very minor damage within city limits in large part due to the preservation of open space and acquisition of high risk structures. For several decades, the Fort Collins Natural Areas Program has proactively purchased property along the Poudre River Corridor, most of which is in the floodplain. In addition, the City’s Parks Department owns and maintains several parks. Table 1 compares the floodplain acreage in the City limits to the amount of open space preserved by the City of Fort Collins. Preserving this land as open space not only minimizes damages during a flood, but it also enhances the natural and beneficial functions of the floodplain including allowing floodwaters to spread out and slow down and providing beneficial habitat (Photo 2).

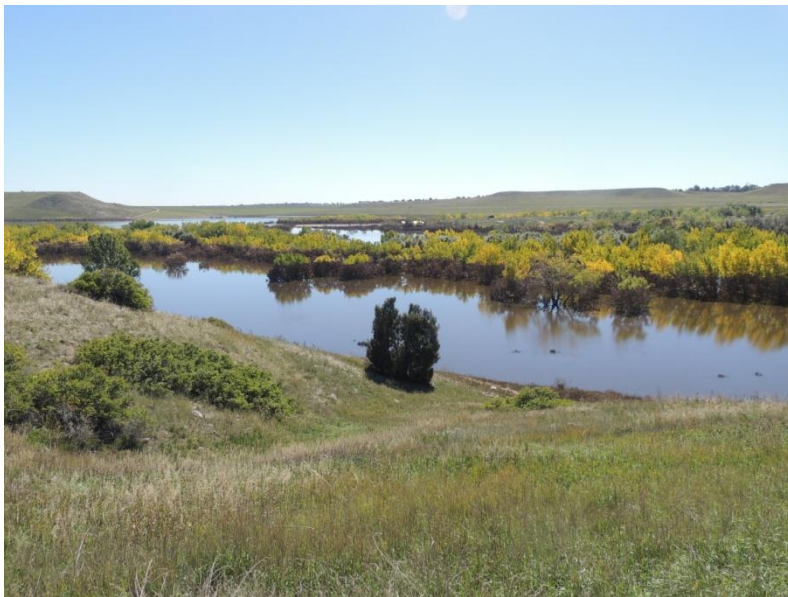
**Photo 3.** Bear Lake Park in Lakewood showing the 2013 high water line on the trees. The water level rose 55 feet during the September flooding.

During the height of the fall floods, the park’s water level rose roughly 55 feet above normal. The park, more than 2500 acres in size, suffered substantial damage due to the high water level, but functioned as it should and protected many people and properties downstream. The water level climbed high enough to submerge picnic shelters, restrooms, docks and trails. The cottonwood trees near the reservoir show the high water level as the foliage below the water was destroyed, leaving the tops of the trees above the water untouched (Photos 3 and 4).

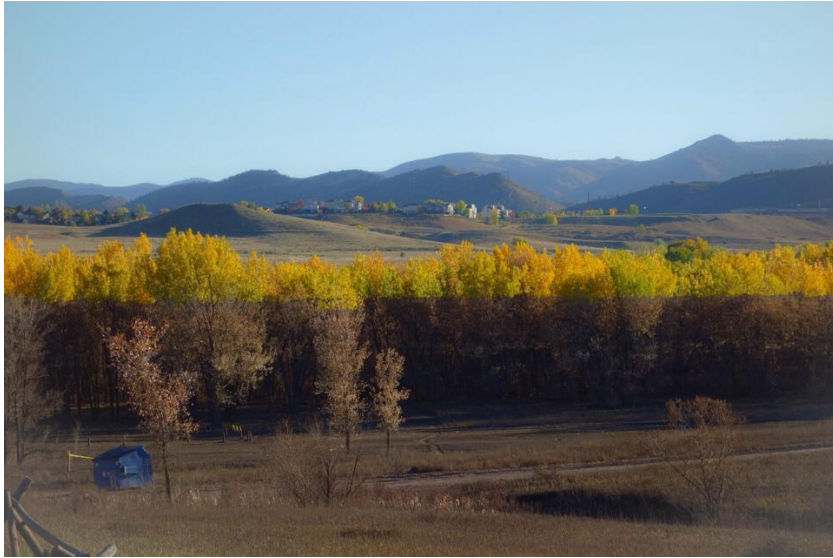
**Photo 4.** Cottonwood trees in Bear Lake Park dramatically show the high water line from the September 2013 flooding. The leaves below the high water line were destroyed, leaving the tops of the trees untouched and still able to display their fall colors. Photo courtesy of Lakewood resident, Carole Kaune.

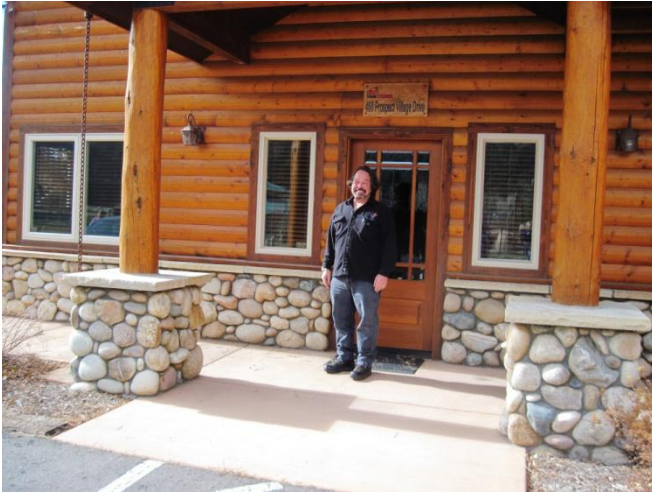
**Photo 5.** An Estes Park business owner next to his building that was not damaged in the 2013 flooding due to elevating the structure.

The Town of Estes Park has not yet joined the CRS. However, they have been looking into the program for a number of years. They already have proactive standards in place that helped provide protection during the 2013 flooding. In the Town's Land Use Code, there are stream setbacks that in most cases result in new construction being located outside the Special Flood Hazard Area. In the past 15 years, there have only been four permits issued for new structures in the 100-year floodplain. All of these buildings were permitted prior to the Town having adopted freeboard standards. However, building permit staff "highly encouraged" those property owners to elevate the new structures. That recommendation paid off because each elevated 2-3 feet above the 100-year flood level and none were damaged in the September floods (Photos 5 and 6). In fact, every building that sustained structural damage, including one that was completely destroyed, was outside the mapped floodplain. The town of Estes Park now has a required freeboard standard of one foot.

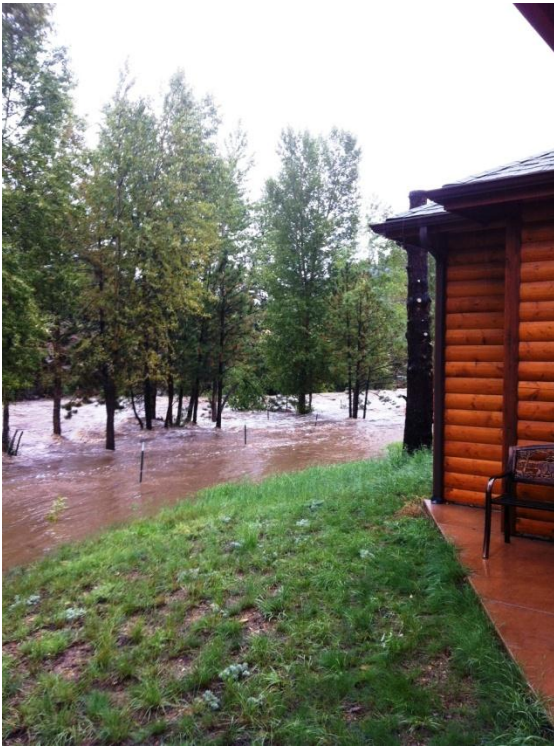
**Photo 6.** View behind the elevated structure looking at the Big Thompson River during the 2013 flooding.
